WRDC-TR-90-4075

FAILURE ANALYSIS TECHNIQUES FOR THE EVALUATION OF
ELECTRICAL AND ELECTRONIC COMPONENTS IN AIRCRAFT
ACCIDENT INVESTIGATIONS

Failure Analysis Associates
115 Flanders Road
Westborough, MA 01581

August 1990

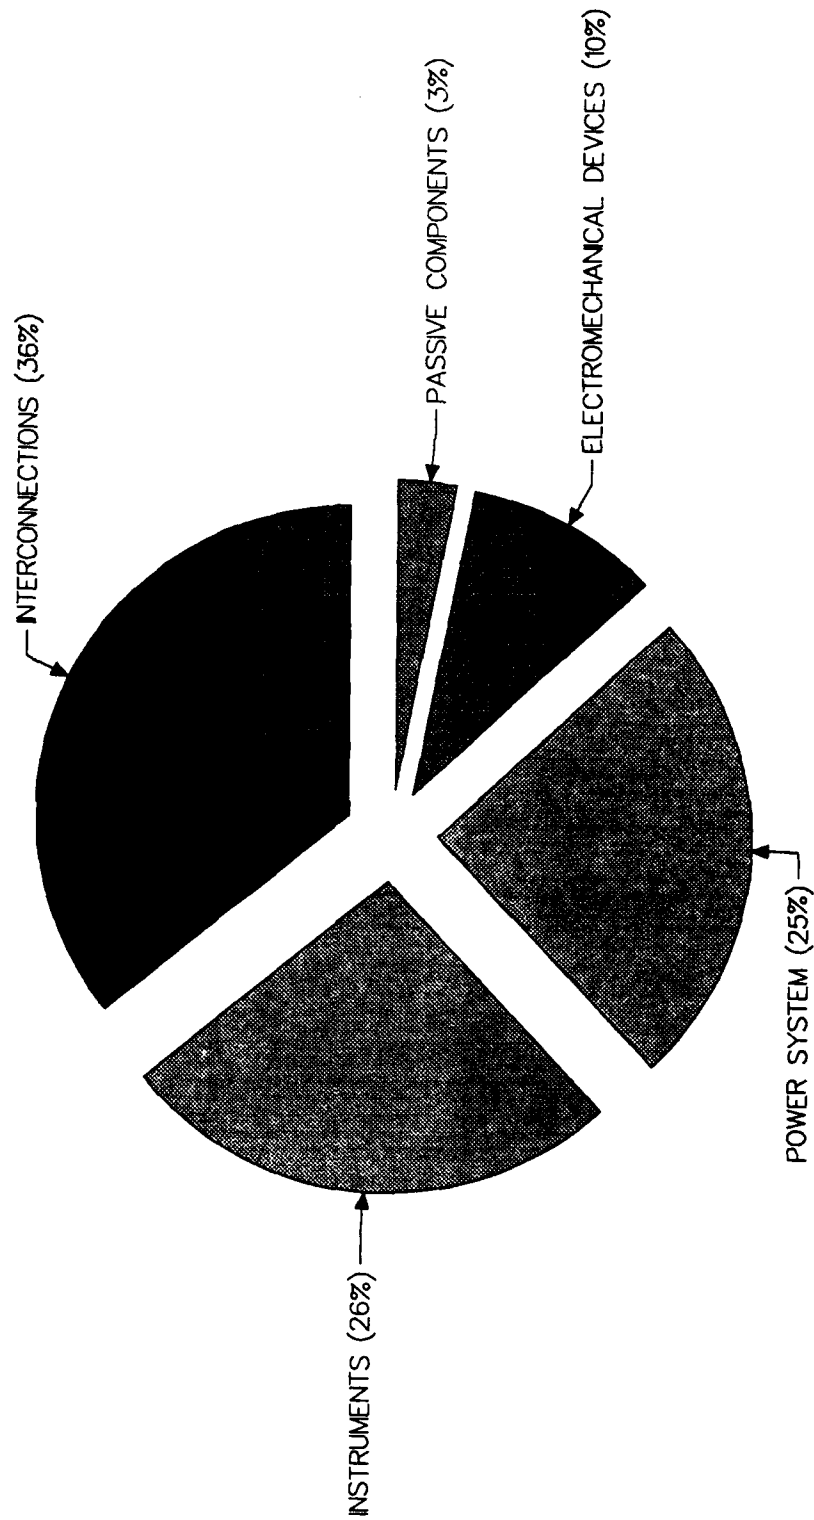
Fig. 2 Summary of Electrically-Related Aircraft Incidents
Approximate Composition by Basic Function
(Based on Data Supplied by Norton Air Force Base [1])
1986-1989

The data of Table 3 have been grouped according to basic system functions and combined percentages for each of the basic functions have been computed as shown in Table 4. The results are represented in Fig. 2. It is apparent from this figure that interconnections (i.e. connectors and conductors (wiring)) are the largest single contributor to electrical failures on aircraft as recorded in the database. The absence of electronic components from the data shown in Figs. 1 and 2 may be due to the level of detail used in the repair or the accident investigation. It is expected that more active and passive electronic components are actually failure causes than are indicated in Figs. 1 and 2. One reason for this is that the materials used in printed wiring boards and electronic components are not likely to survive post-impact damage. This damage may prevent the components from being identified as failure causes even if they did play a causal role in the mishap. As the complexity of installed electronic equipment continues to grow and fly-by-wire aircraft become more common, accident investigation analysis will be driven to identify electronic devices despite the difficulties caused by post-impact damage.

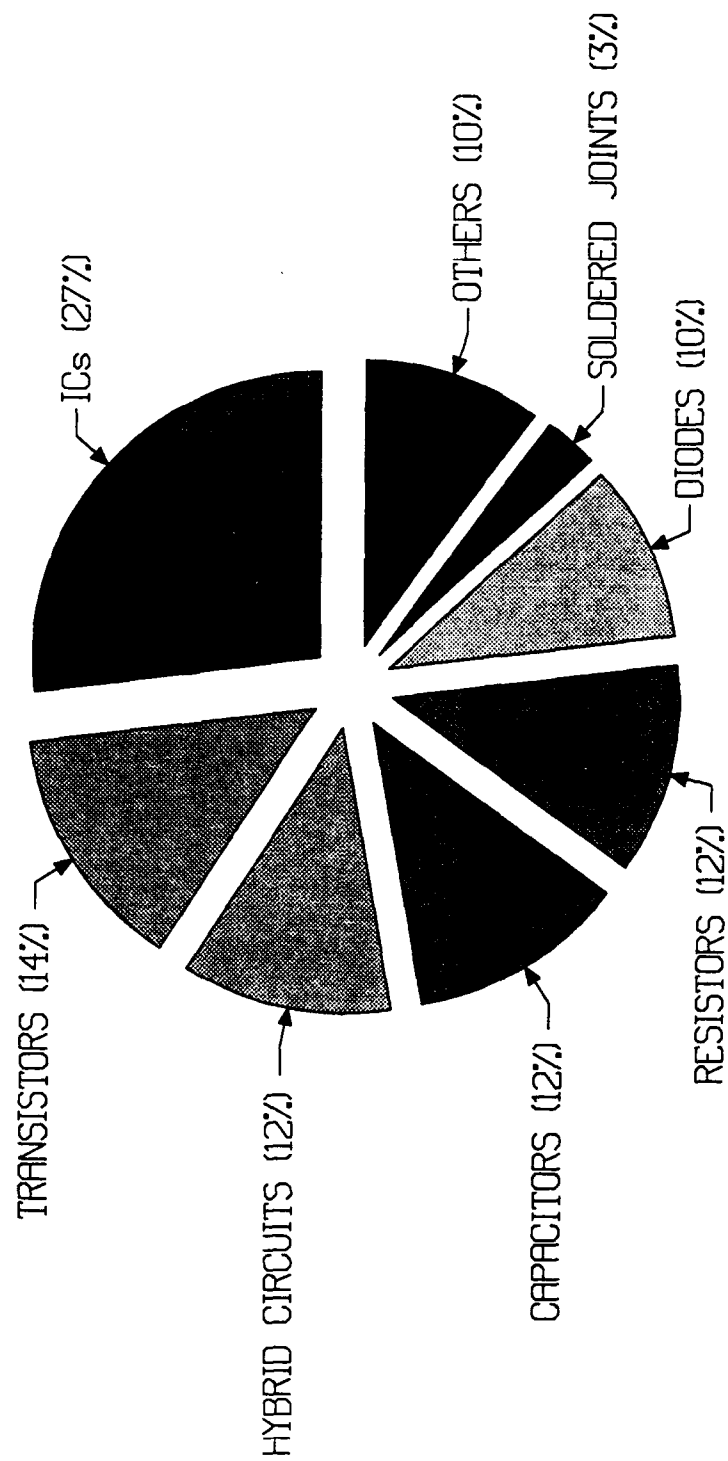
Fig. 4 Part Replacement Data for Printed Wiring Boards

A study based on repair records for printed wiring boards (PWBs) at Hughes Aircraft [3] presented data which is depicted in Fig. 4. The data is accumulated from four types of PWBs of different ages and complexity levels. The study was based on part replacement data from factory test and quality control activities, not field failures. Over 58,000 repair records were used as the initial source of data for the study. The goal of the study was to rank components in terms of their replacement frequency rather than their failure rate. The reported composite replacement frequency ranking (from highest to lowest) was: ICs; transistors; hybrid circuits, capacitors and resistors; diodes.

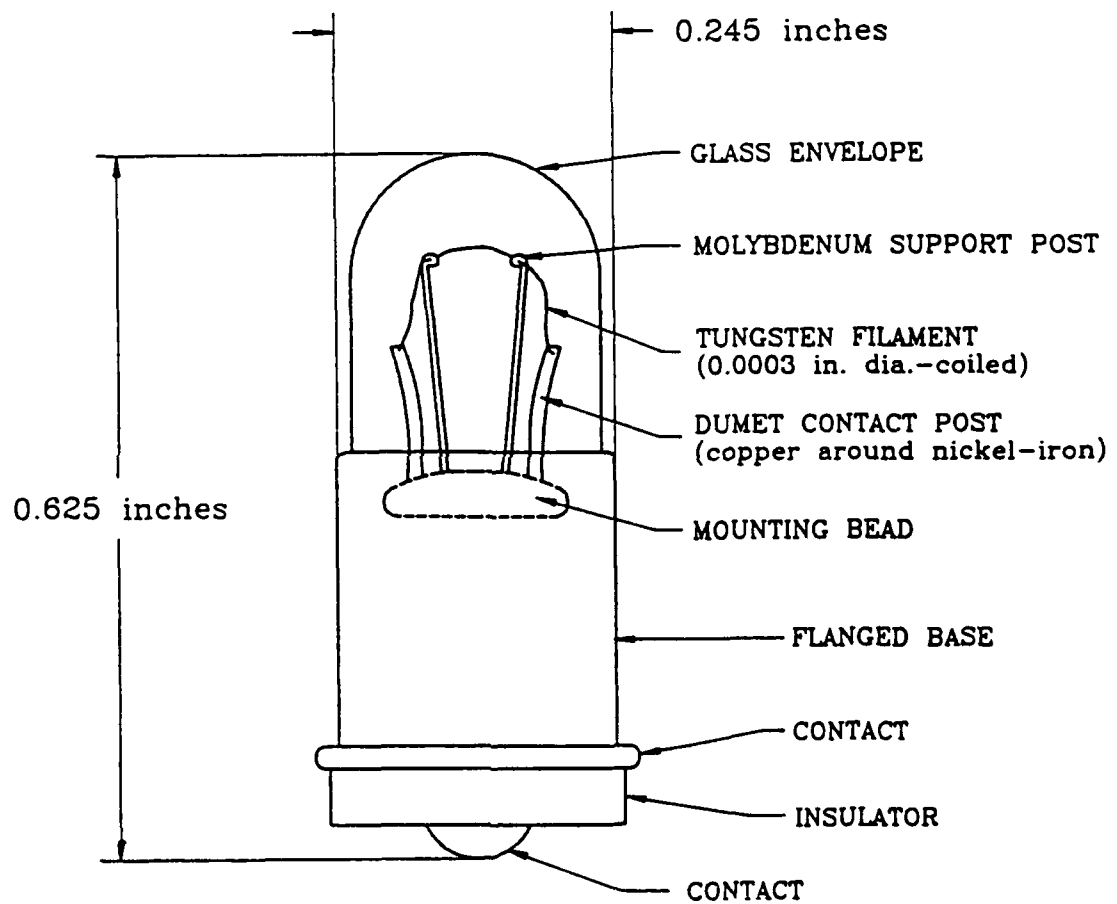
Fig. 2.1 General Construction of
Type 327 Lamp

The material used for the filament is tungsten wire, which is typically made by a powder metallurgy process. A nearly pure form of tungsten is used for lamp filaments. The filament for a 327 lamp is about 300 microinches in diameter, has a total (uncoiled) length of about 2.1 inches, and has a mass of about 40 micrograms. Mechanical properties of Tungsten wire include tensile strengths from 250,000 to 600,000 psi at room temperature, depending on the diameter [2.6]. The tensile strength at the operating temperature of 1500 to 2000°C can be as much 20 times lower than at room temperature. Other data on the 327 lamp is presented in Table 2.2. Military standard MS 25237 [2.7] describes the mechanical and performance requirements of the 327 lamp.

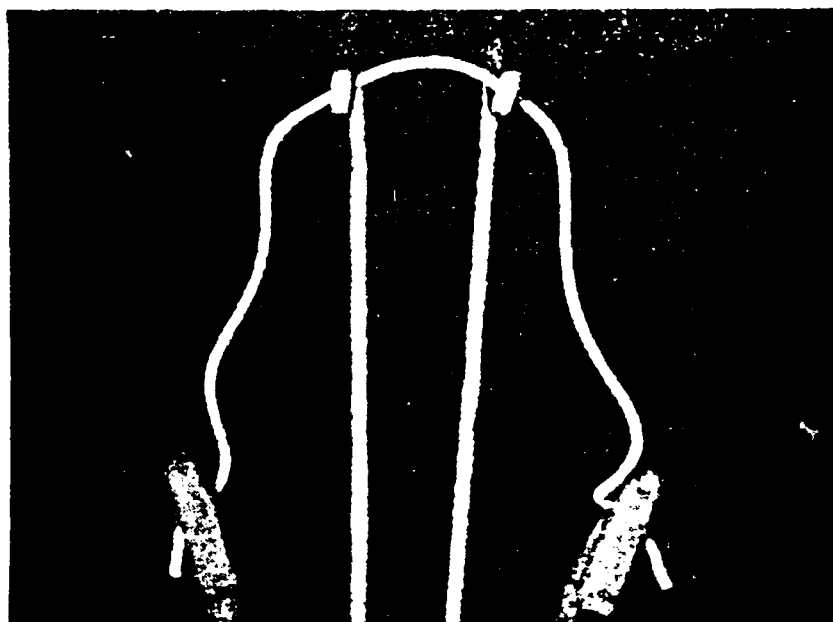
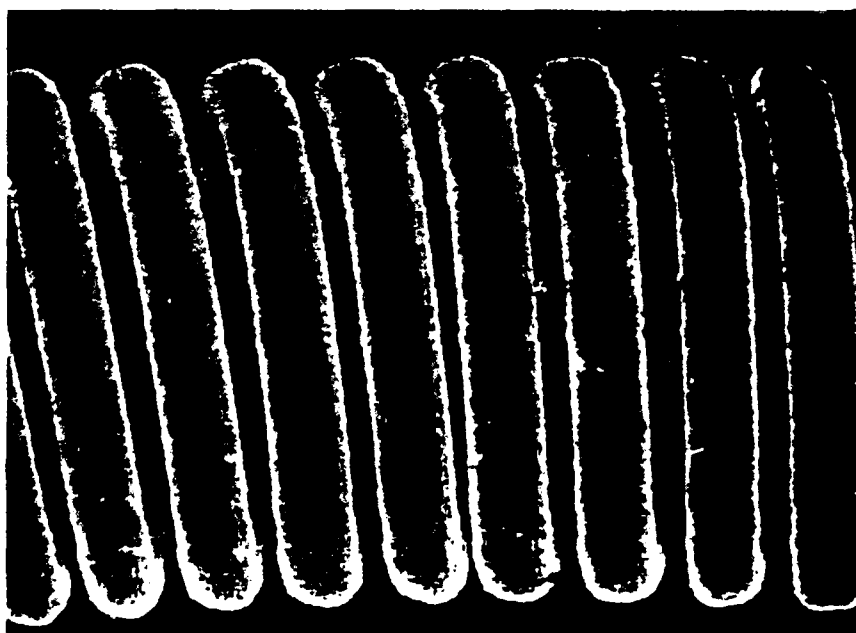
Fig. 2.2 New filament of Type 327 lamp [2.1]. a - 20X, b - 1000X.

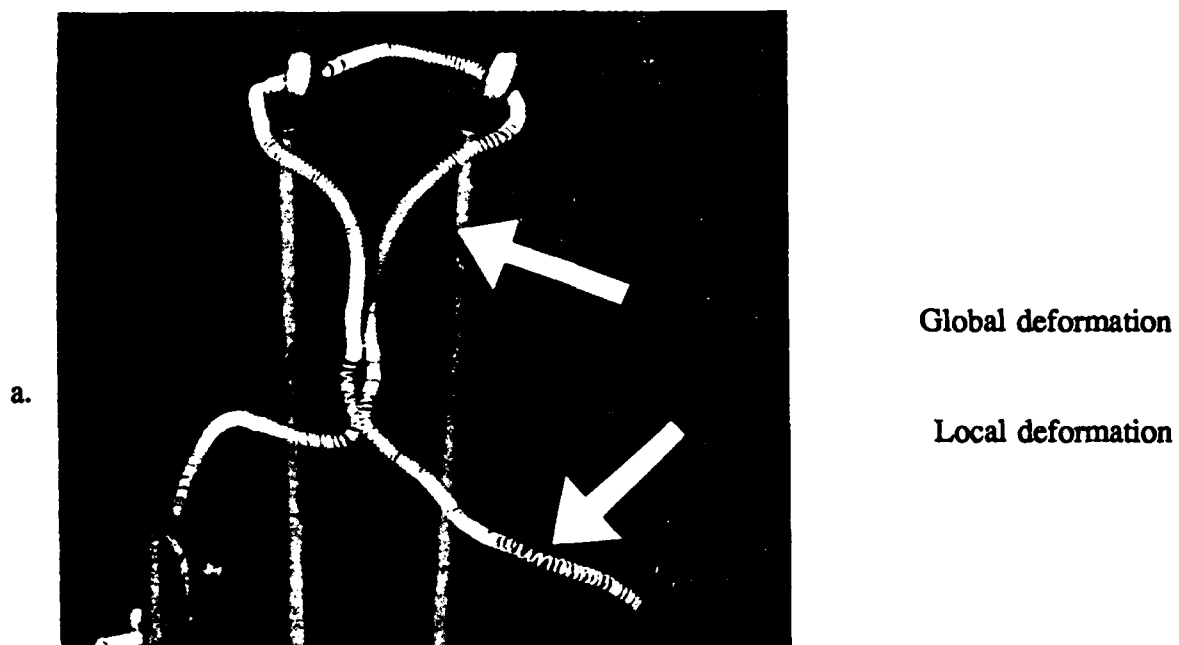
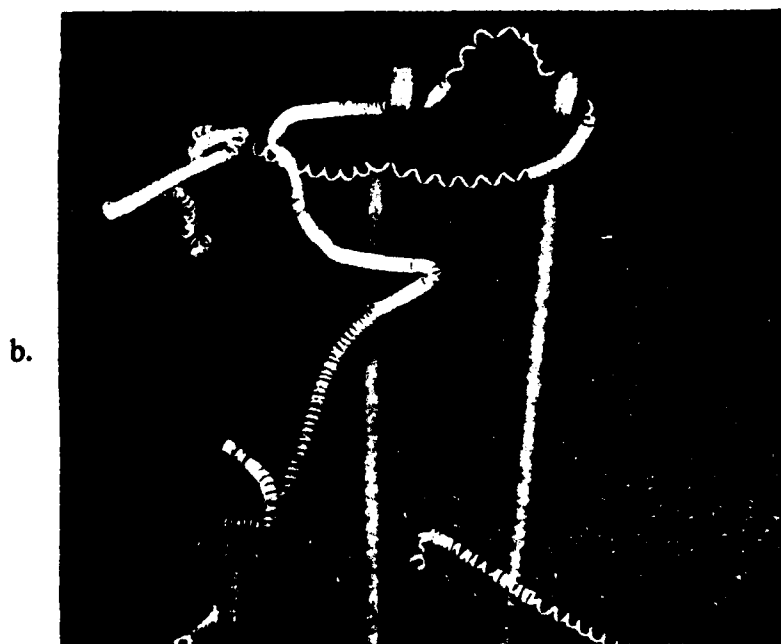
Fig. 2.4 Deformation of filament impacted at 4006 G for 0.9 millisec. Filament ON.
(a) Global and local deformation (b) Resonance and multiple fractures (Ref. 2.1).

Impacts containing high frequency components produce other distinct deformation characteristics. In high-g, short duration impacts the support posts can resonate and cause severe deformation, tangling, and multiple filament fractures. This type of resonance deformation is shown in Fig. 2.4b. The loading on the filament was a peak acceleration of about 4000 g's occurring over a period of about 0.9 msec [2.1]. Violent resonance of the support posts and filament of the 327 lamp can occur when excited between 1300 and 1550 Hz [2.1]. For very short duration impacts that excite this resonance lower g values of acceleration can cause failure. Hot filaments tend to show extreme amounts of local and global deformation. Cold filaments typically fracture with little or no deformation. A half sinusoidal deceleration corresponding to 1300 Hz would last about 385 microseconds.

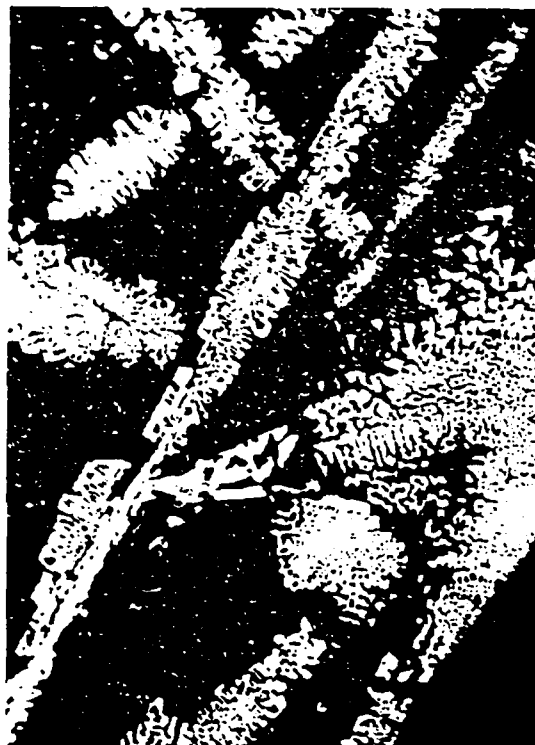
Fig. 4.5 Grain structure of solder joint (60-40) contaminated with 15% Gold. Large white crystals are AuSn_4 [4.8].

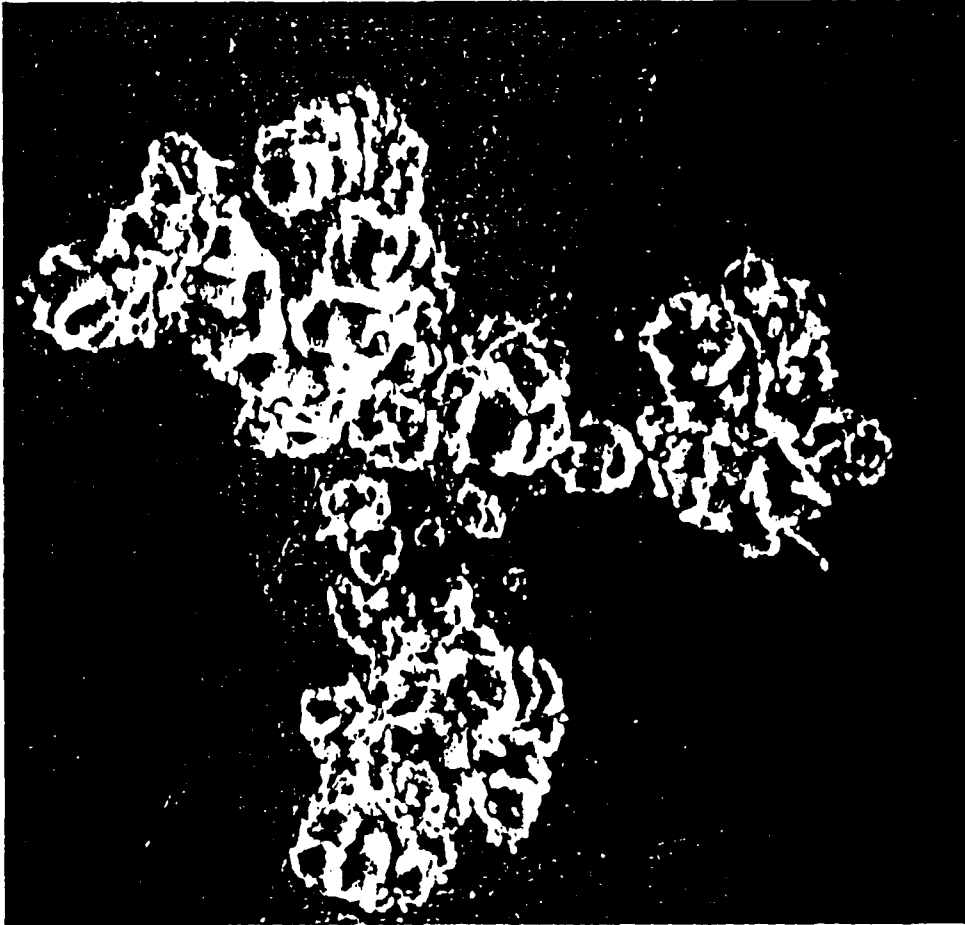
Fig. 5.3 SEM photograph of contact damage on gold electrodes sustained during one gas breakdown discharge. 20,000 x. [5.8].

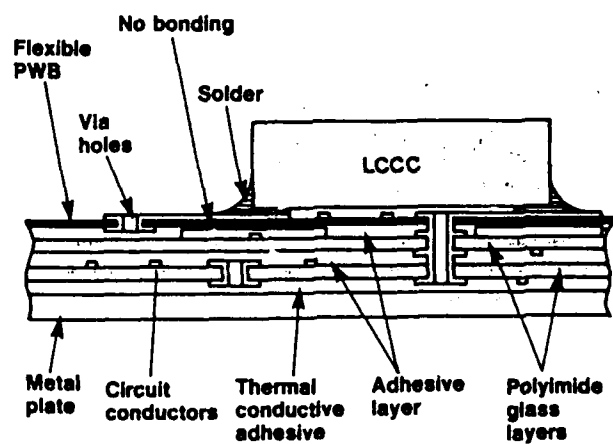
Fig. 7.5 Compliant layer printed wiring board [7.3].

In through-hole boards the component leads fasten the components to the board. However, in surface-mount construction the solder joints alone provide the mechanical fastening of the components as well as the electrical connection. Without the compliant lead connection, mismatch between the coefficient of thermal expansion (CTE) of the components and the board material causes considerable stress on the solder joints [7.2]. Metal core boards have been developed to remove heat and help control the CTE of the board material. Fig. 7.4 shows a copper-invar-copper board construction designed to reduce solder joint stress in surface mount applications. Another construction, shown in Fig. 7.5, uses a compliant surface layer to reduce solder joint stress [7.3].

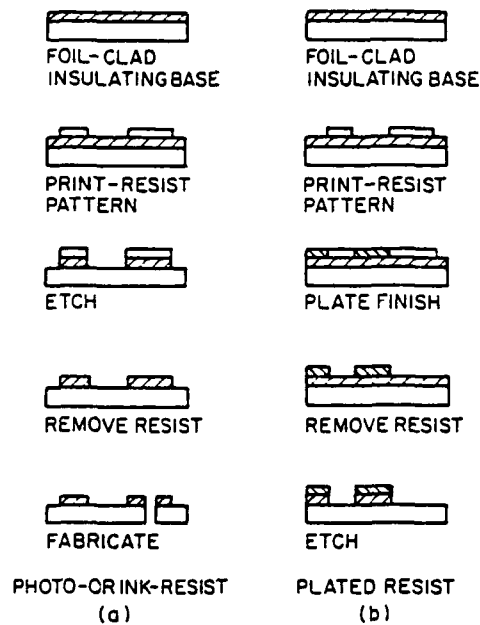
Fig. 7.7 Steps in two processes for single sided printed wiring boards [7.1].

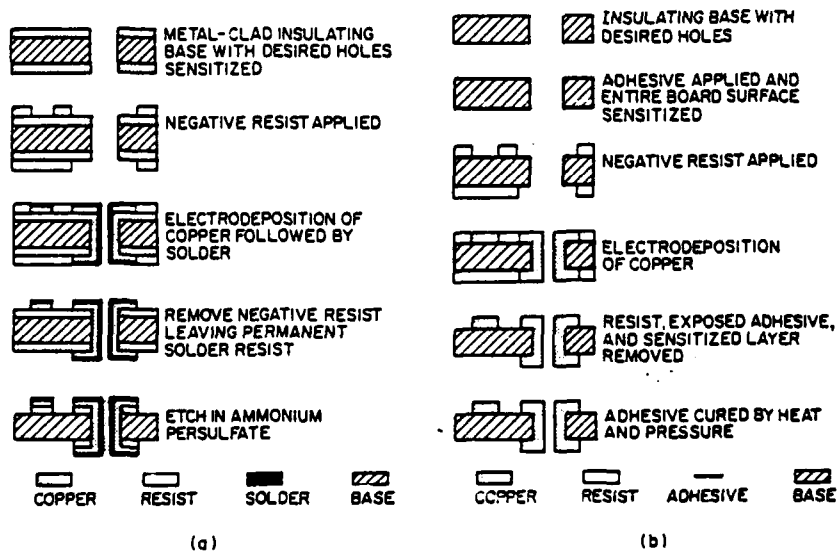
Fig. 7.8 Steps in subtractive (a) and additive (b) process for boards with plated-through-holes [7.1].

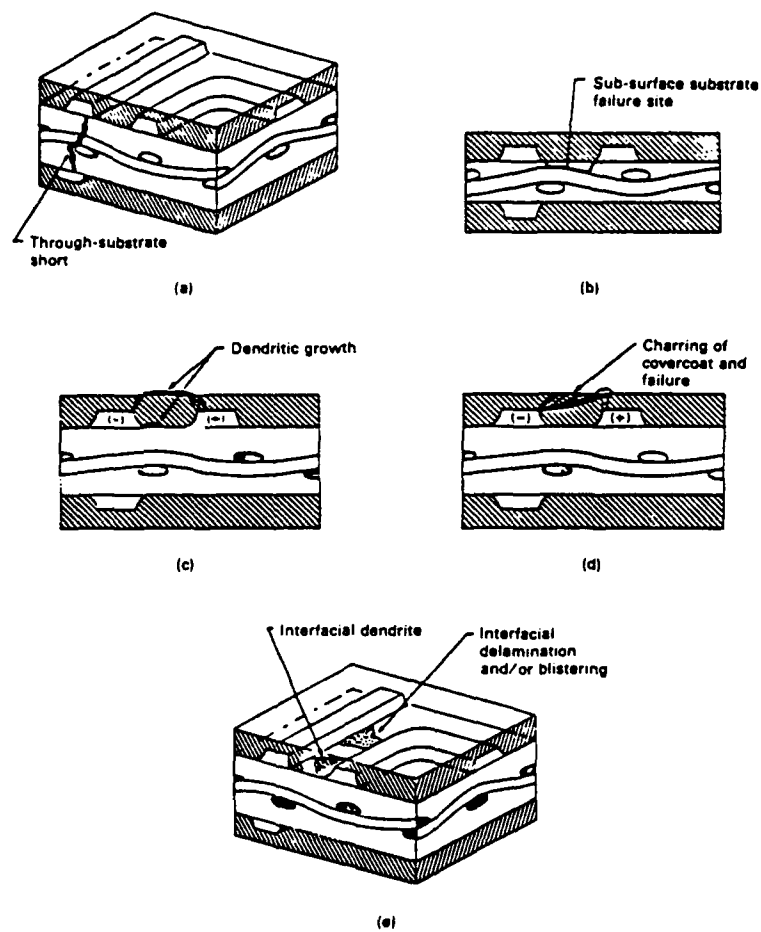
Fig. 7.12 Insulation failures on printed wiring boards [7.1].

The standard procedures measure insulation resistance between traces using special trace patterns. Applied voltages are 100 or 500 Vdc and typical minimum resistances are 100 to 500 M Ω . A
